## Concrete Delamination Analysis and Repair Methods in Residential Buildings

In residential construction projects, particularly multi-story buildings, concrete delamination in critical structural elements such as columns and basement walls can pose serious challenges to both structural integrity and project timelines. The 4-story residential building project examined in this study encountered concrete delamination issues in first-floor columns and basement walls, necessitating appropriate remedial measures.

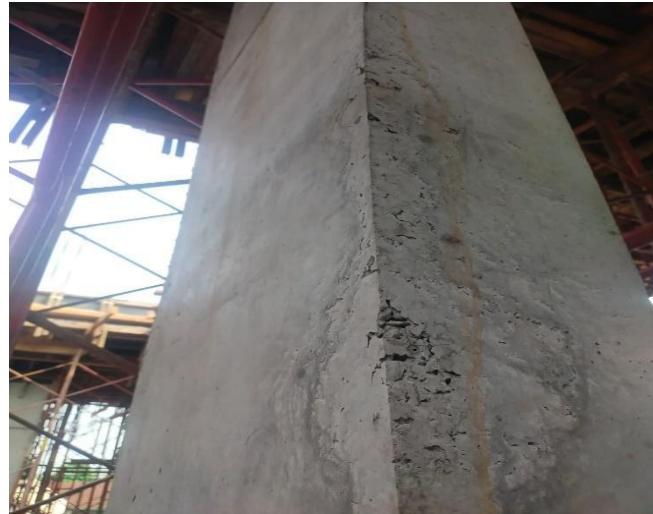
1. Poor Concrete Mixture: Analysis of the concrete mix showed inconsistencies in aggregate distribution and water-cement ratio, leading to reduced cohesion between concrete layers.
2. Segregation During Pouring: When concrete was poured from heights exceeding 1.5 meters, significant segregation occurred, causing separation of fine and coarse aggregates. This segregation created weak planes within the concrete structure that later manifested as delamination.
3. Inadequate Vibration: In some areas, insufficient vibration during concrete placement resulted in air voids and poor compaction, creating potential delamination planes.
4. Formwork Issues: Premature removal of formwork in certain sections contributed to surface delamination, particularly in areas exposed to environmental stressors.

Figure 1 illustrates the delamination observed in a first-floor column, while Figure 2 shows the repair process using the plastering method.

**Figure 1.** Delamination In A Column

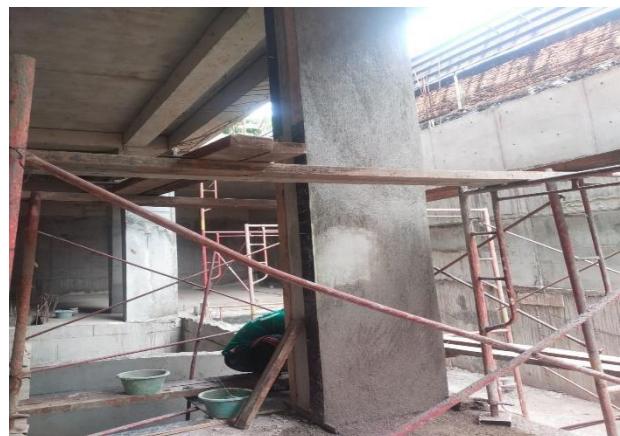
**Figure 2.** Repair Process Using The Plastering Method

1. Grouting: Applied in areas with deep delamination, this method involved injecting cementitious grout into voids to restore structural integrity.
2. Plastering: This method proved most effective for the residential building project due to its cost-efficiency and the ready availability of materials (fine sand and cement). The process involved removing loose concrete, cleaning the surface, applying a bonding agent, and applying a cement-sand mortar mix.
3. Injection: For narrow cracks and delamination, epoxy injection was used to restore structural continuity.

The effectiveness of each method was evaluated based on durability, cost, and ease of application. The plastering method emerged as the most practical solution for this specific project, providing adequate repair while remaining cost-effective and requiring readily available materials.
